DEPARTMENT OF TRANSPORTATION

Quality Assurance and Source Inspection

Contract #: 04-0120F4Cty: SF/ALA Rte: 80 PM: 13.2/13.9File #: 69.28**WELDING INSPECTION REPORT****Resident Engineer:**Pursell, Gary**Address:** 333 Burma Road**City:** Oakland, CA 94607**Report No:** WIR-012022**Date Inspected:** 11-Feb-2010**Project Name:** SAS Superstructure**OSM Arrival Time:** 645**Prime Contractor:** American Bridge/Fluor Enterprises, a JV**OSM Departure Time:** 1845**Contractor:** Zhenhua Port Machinery Company, Ltd (ZPMC), Changxing Island **Location:** Shanghai, China**CWI Name:** Wu Chi Chang**CWI Present:** Yes No**Inspected CWI report:** Yes No N/A**Rod Oven in Use:** Yes No N/A**Electrode to specification:** Yes No N/A**Weld Procedures Followed:** Yes No N/A**Qualified Welders:** Yes No N/A**Verified Joint Fit-up:** Yes No N/A**Approved Drawings:** Yes No N/A**Approved WPS:** Yes No N/A**Delayed / Cancelled:** Yes No N/A**Bridge No:** 34-0006**Component:** OBG COMPONENT**Summary of Items Observed:**

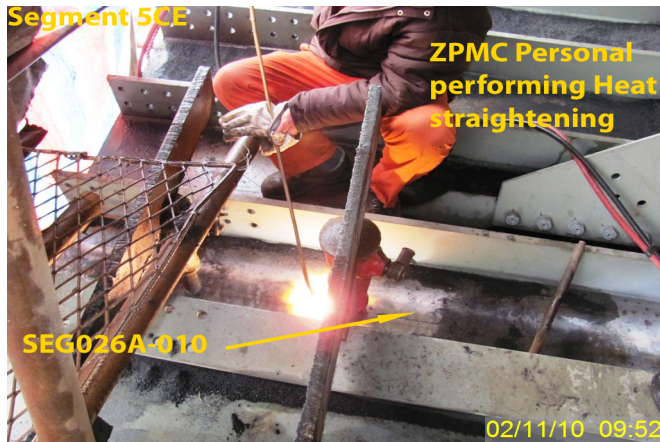
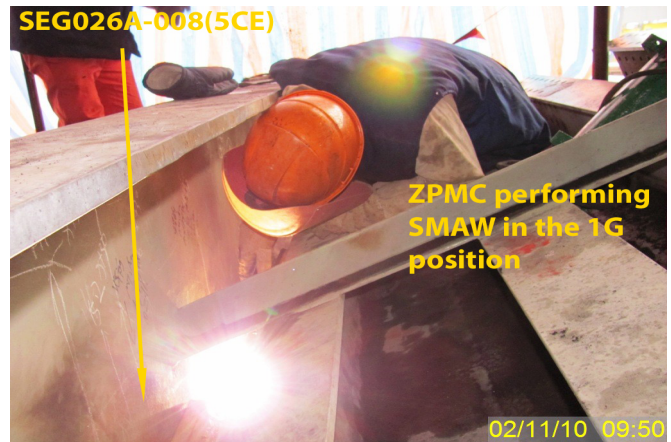
FCAW in the 3G position for the OBG Segment 7AW to 7BW, weld No.BP035-001-38. The welder is identified as #066746. ZPMC QC is identified as Mr. Li Yang. The welding variables recorded by QC appear to comply with WPS-B-T-2233-B-U2-F.

SMAW in the 1G position for the OBG Segment 5CE, weld No.SEG026A-008. The welder is identified as #066179. ZPMC QC is identified as Mr. Yang Qong. The welding variables recorded by QC appear to comply with WPS-345-SMAW-3G (3F)-FCM-REPAIR-1. The weld repair report is identified as B-CWR-1201.

During in process inspection the QA Inspector observed that the ZPMC personal doing heat straightening on butt weld joint joining at Segment 5CE side plate SP306A to SP425A bike path side .The weld joint is identified as SEG026A-010 . And the heat straightening report identified as HSR(B)-353.

This Quality Assurance (QA) Inspector performed random visual inspection of OBG segment 7DW internal side panel, bottom panel, floor beam and longitudinal diaphragms surfaces from the panel point 56 to 57 after grit blasting. Areas that marked for repair were recorded for future repair. Areas requiring additional grinding were marked by QA and repaired by ZPMC personnel.
